Efficient single run – multi ball seat PRIME Milling operation

A North Sea customer had a new and critical offshore water injection well which was not performing as expected, having an injection rate well below target.

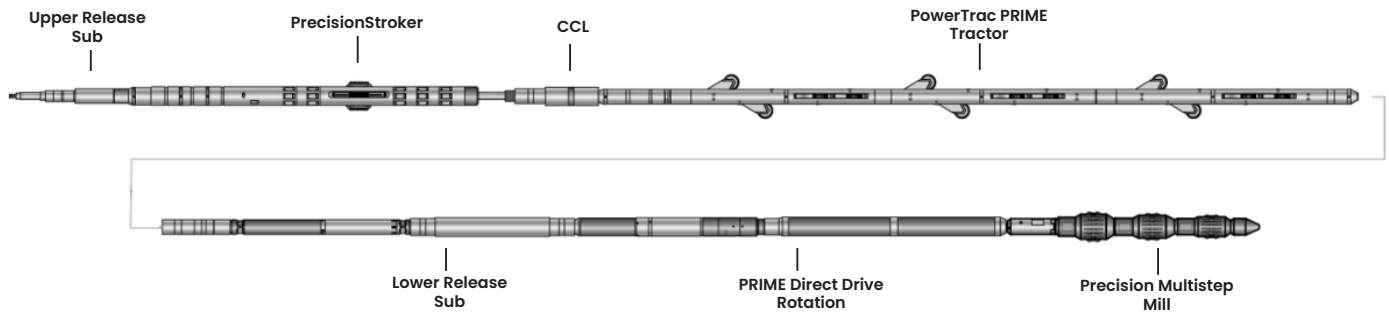
Toolstring used for the milling operations

incorporating a high level of instrumentation for real-time measurement and control of parameters that are critical to milling optimization. The **PowerTrac PRIME Tractor** would provide high speed toolstring conveyance of the milling assembly to task depth. Once there, it would then provide rotational anchoring and weight-on-bit (WOB) in support of the milling task across the horizontal well section.

Tension/compression subs placed above and below the tractor would provide in-situ measurements of the WOB throughout the operation. The **PRIME Direct Drive Rotation** device would provide the rotational torque.

Monitoring and adjusting the torque, WOB, and rotational speed in real-time would enable an optimized rate of penetration throughout all steps across all ball seats, handling the spread of ball seat dimensions confronted during operation. The weight on bit would be adjusted by regulating tractor forward force, to keep the milling rotational speed and torque within the optimum operating range that was determined during pre-job tests.

A **PrecisionStroker** was also added to the toolstring to enable immediate high force pulling capability to free the toolstring if it were to get stuck in hole. As a further precaution, controlled release subs were also included in the string. Neither of these contingency measures were required for the operation.

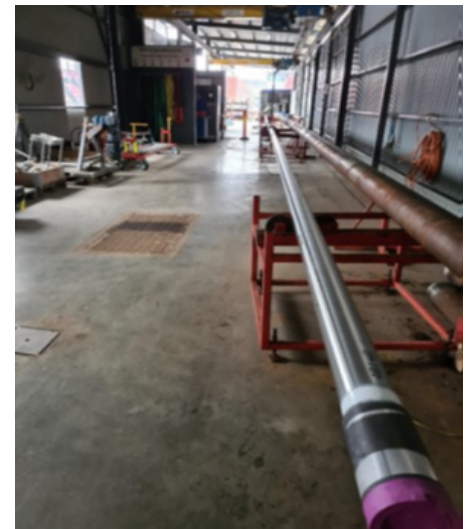
Ball seats provided to engineering for milling tests

Thorough pre-job tests were carried out at our engineering facility on identical ball seats that were placed in a test-jig set up.

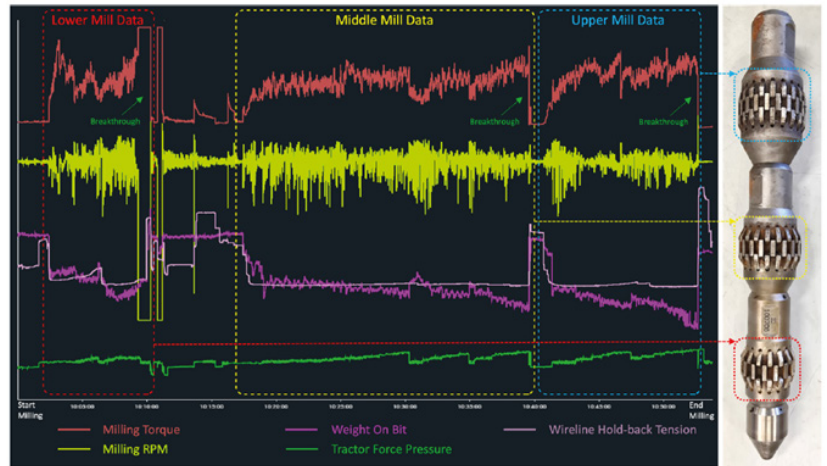
Example log data taken from a pre-job test done at the onshore engineering facility

Critical tool parameters captured in real-time during the testing provided clarity and understanding of the milling sequence of each ball seat, with mill engagement and breakthrough of each mill clearly determined from the multitude of toolstring data curves available.

Typical indications of milling progress seen via surface readout are user-increased weigh-on-bit resulting in increased milling torque and reduced milling rpm; and increased downhole wireline tension as the tool mills further into the ball seat.

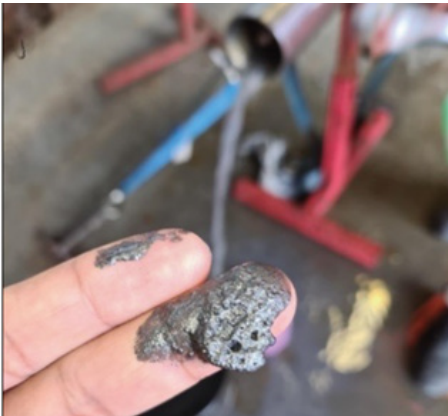
Swarf collected following milling tests

The swarf produced by the milling operation was found to be powder like, leaving no concern with regards to hindrance of the subsequent electric line perforation runs or a detrimental impact on the well injectivity.
